# GASIL

GENERAL AVIATION SAFETY INFORMATION LEAFLET

The CAA Accident Prevention Leaflet

2 of 2006 issued June

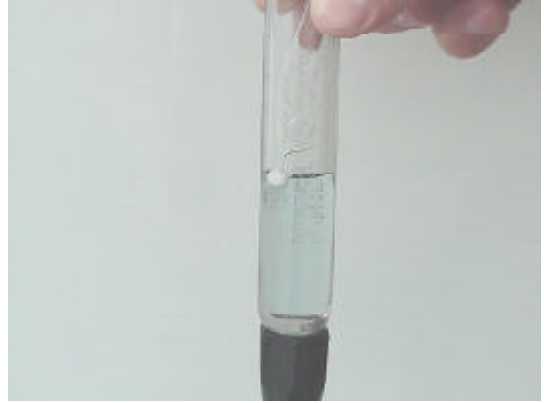
Not everyone has a concrete apron (tarmac is adversely affected by fuel). Other suggestions include spitting into the sample and checking the bubble does not dissolve, as shown in the picture. More specific checks however can be made with water test capsules and paste.

1. Drain fuel to the tip of the indicator in the fuel sampler.
2. Sniff it - does it smell like fuel?
3. Look at it. Hold the sampler against the white back of the checklist, check for pale blue colouration (Avgas 100LL) - and no bubbles of water at the bottom of the sampler.
4. Throw the liquid on the concrete and check that it evaporates rapidly. However, these days to protect the environment the common solution is to pour whatever was in the sampler back into the tank **provided, of course, that it was 100% fuel.**

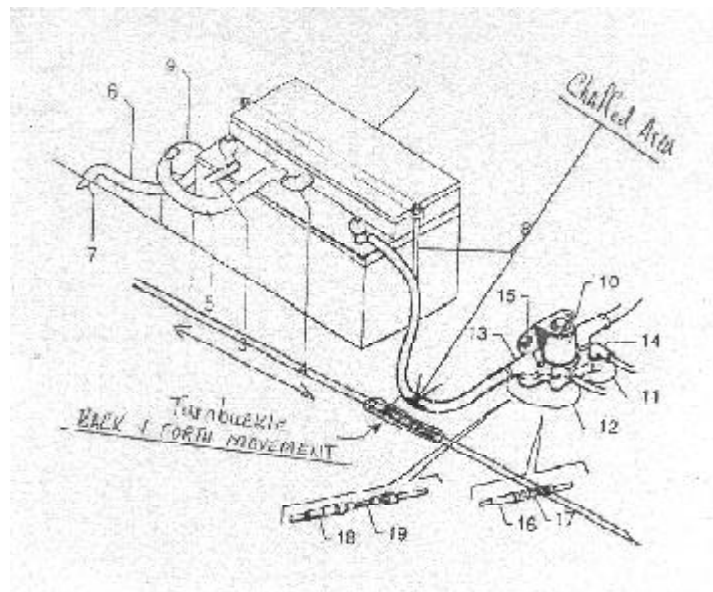
In the FAA's Maintenance Alerts published in December, another incident is reported concerning cable chafing. In this case, the turnbuckle of a control cable (not specified) in a PA-28-181 was the culprit. It was found during routine maintenance to be rubbing against the positive battery cable, as illustrated below. The report indicates that the problem had been identified during the previous inspection, but although the battery cable had then been repositioned to provide clearance, it had worked its way back to its original position, where its insulation had been chafed almost through.
